ENGINEERING BULLETIN #176

Failure Analysis: Identifying the Corrosion Culprit

CASE STUDY: STEAM HOSE FAILS WITHIN ONE YEAR OF OPERATION

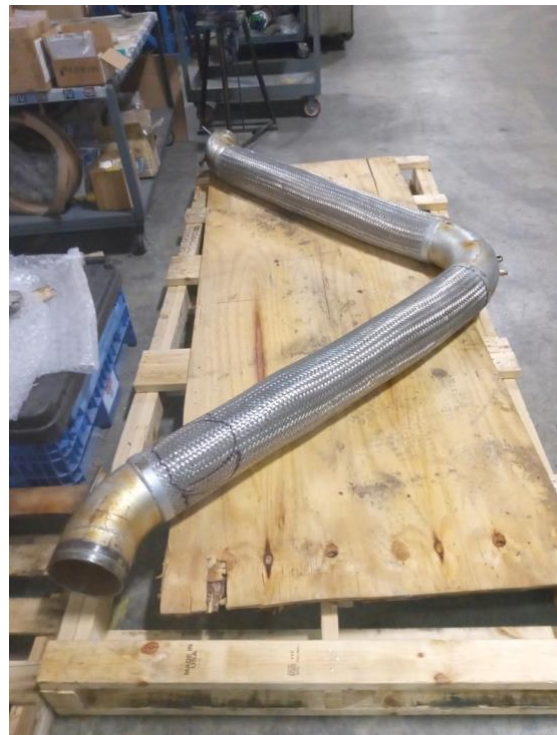
To give an example, have a look at the V-Loop assembly pictured here which looks just fine. Had the user not circled the site of the leak with permanent marker, we would not have been able to locate it through visual inspection alone.

The six-inch assembly was conveying steam at ambient temperature. Maximum working pressure was 165 PSI. The only movement to which the hose was subject was seismic vibration. After a year in service, operators noticed a leak at one end of the hose.

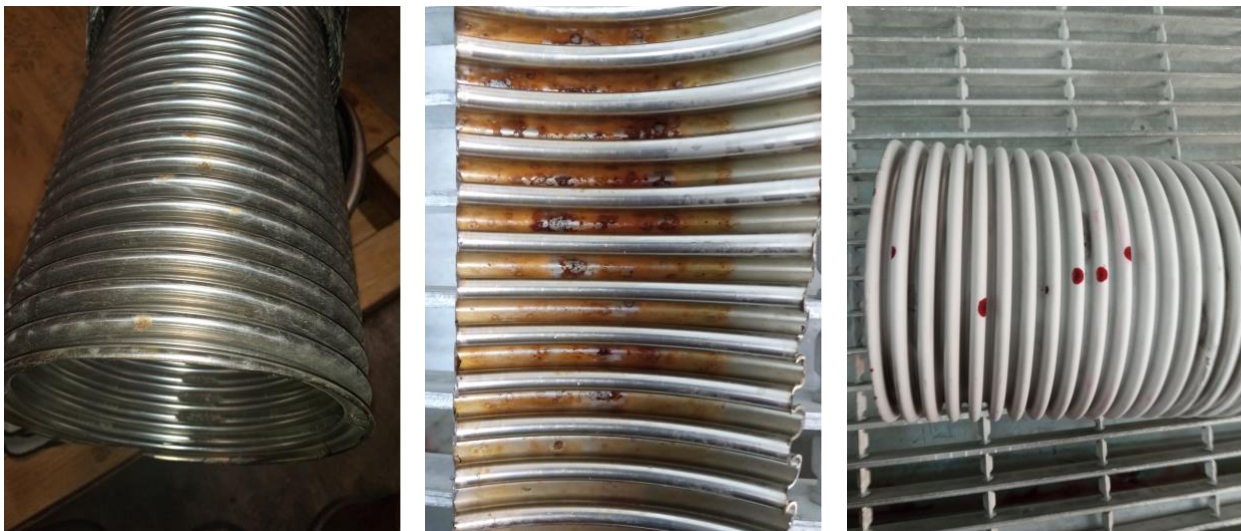
After visual inspection, the next step in our failure analysis process is to remove the braid and examine the exterior of the bare hose. Corrosion spots were immediately visible upon removing the braid from the V-Loop assembly. Notice what looks like small rust spots on the corrugations.

Since the braid didn't show any signs of corrosion, corrosion presumably worked its way from the inside out. Flow media was likely the culprit. Had the corrosion been caused by [environmental factors](#), whether those be in play due to geographic location (i.e., beside the ocean) or due to sprays, leaks and drips, corrosion would have worked its way from the outside in. This hypothesis was also supported by the fact that welds were of high quality and there was no mechanical damage, meaning there were no other areas vulnerable to chemical attack aside from those spots on the corrugations.

We needed to see the inside of the hose to confirm our suspicion. Extensive corrosion was visible upon cutting the affected hose section open, proving our hypothesis that corrosion was caused by the steam running through the hose. That corrosion was largely confined to one side of the hose suggests steam condensate had been laying inside the hose at some point.

[Dye penetrant inspection](#) was then performed to confirm the location of holes. The spots and through holes are symptomatic of pitting corrosion, the most common cause of which in stainless steel is acid chlorides. The steam running through this hose was not simply steam.

With an understanding of the failure mechanism, we considered design inputs like alloy and wall thickness to offer the user a recommendation for the replacement hose. In this scenario it would make sense to consider using 316 stainless instead of 321 as it resists chloride corrosion better

thanks to the addition of molybdenum. A hose made with 316 should last longer in the application.

The user could also carry out an analysis of the steam composition for a more accurate picture of which chlorides in what concentration are present.
